SPECIAL AIRWORTHINESS INFORMATION BULLETIN

No. NE-01-22
May 11, 2001

This Special Airworthiness Information Bulletin (SAIB) alerts you an owner or operator of **Textron Lycoming Division, AVCO Corporation (Textron Lycoming) O-235; O-290; O-340; (L)O and IO-320, -360, -540; AIO-320, -360; AEIO-320, -360, -540; HIO-360; and TO-360 series reciprocating engines**, with fuel pumps, Part Number (P/N) LW-15472, P/N LW-15473, or P/N LW-16335 installed, **and** that has one of the manufacturing date codes listed below as scribed on the edge of the pump mounting flange. See Figure 1.

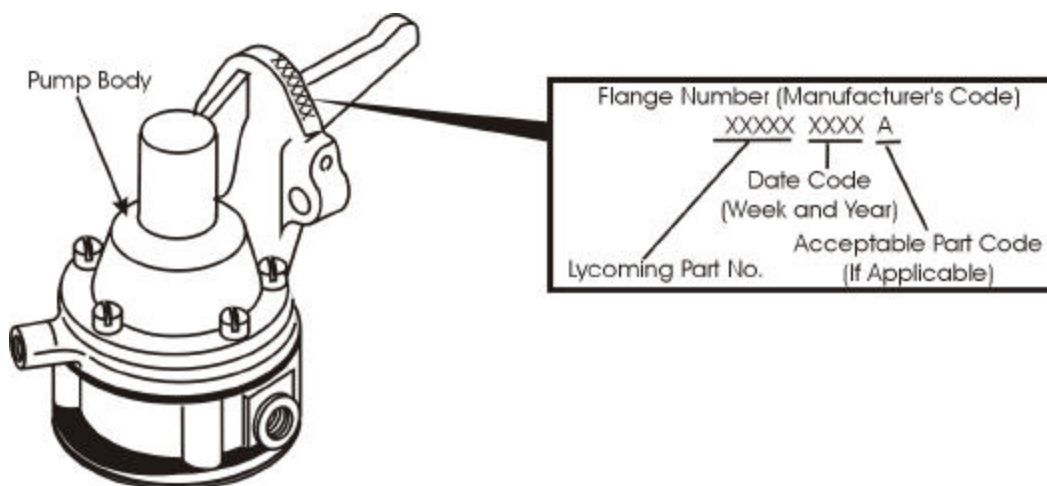
Textron Lycoming issued their Service Bulletin (SB) No. 548 determining that several lots of diaphragm-type fuel pumps may have a potential for an internal failure. When an internal failure occurs, the check valve seat separates from its shaft due to an inadequate or improper assembly crimp. This allows the liberated parts to move within the housing and may cause a blockage of fuel flow. This failure may not be evident on the exterior of the pump, but it may result in a decrease or loss of fuel flow and a corresponding decrease or loss of power. Textron Lycoming estimates that approximately 1,252 fuel pumps were manufactured between September 18, 2000 and February 18, 2001 with a potential to fail, but they can not predict if or when the failure may occur.

- Textron Lycoming engine that has a diaphragm-type fuel pump, Lycoming P/N LW-15472, LW-15473, or LW-16335 installed, with one of the following date codes in the 6th through 9th digit locations scribed on the pump:

3900	4000	4100	4200	4300	4400
4500	4600	4700	4800	4900	5000
5100	5200	0101	0201	0301	0401

Example: 163354800 should be inspected and replaced as specified in Textron Lycoming Service Bulletin 548

- If the letter “A” is marked as a suffix to the date code, *the pump has been repaired by the pump manufacturer and replacement is not necessary.*

Example: 163354800A

To prevent a failure of the Textron Lycoming fuel pump, P/N LW-15472, LW-15473, or LW-16335, we highly recommend you inspect your engines for the applicable fuel pumps as shown in Figure 1 below and replace it as described in Textron Lycoming Service Bulletin (SB) No. 548. We recommend you should also check your maintenance records for affected replacement fuel pumps received after February 8, 2001.
